## FIELD SERVICE REPORT FORM

My Site

THURSDAY 13TH NOVEMBER 2025

| Q# | QUESTION | RESPONSE |
|---|---|---|
| 12. | Equipment make and model | Make: Frigidaire Pro-Line; Model: FPLR-4500-SS (Side-by-Side Commercial Unit) |

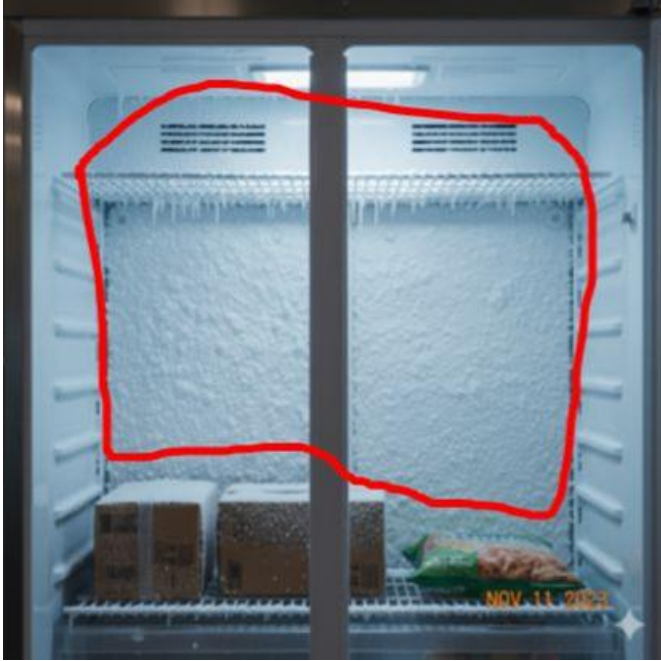
16. Photo evidence of defects or damages (attach or upload)

| Q# | QUESTION | RESPONSE |
|---|---|---|
| 15. | Description of problem or defect found | Found a suction line leak at the filter dryer weld joint. The compressor is dead, drawing high LRA and tripping thermal overload due to low charge and a dirty condenser. |

| 18. Cleanliness of unit | Poor. Heavy dust/lint buildup observed on the condenser coil and fan blades upon inspection of the back panel. This contributed to poor heat exchange. |

| Q# | QUESTION | RESPONSE |
|---|---|---|
| 27. | Description of work performed or actions taken | Isolated unit and manually defrosted coils. Recovered refrigerant. Cut out and brazed in a new compressor and filter dryer. Pressure tested with nitrogen, then evacuated the system for 4 hours due to contamination. Recharged with 2.8 kg of R404A. Tested unit operation and verified temperature pull-down. |

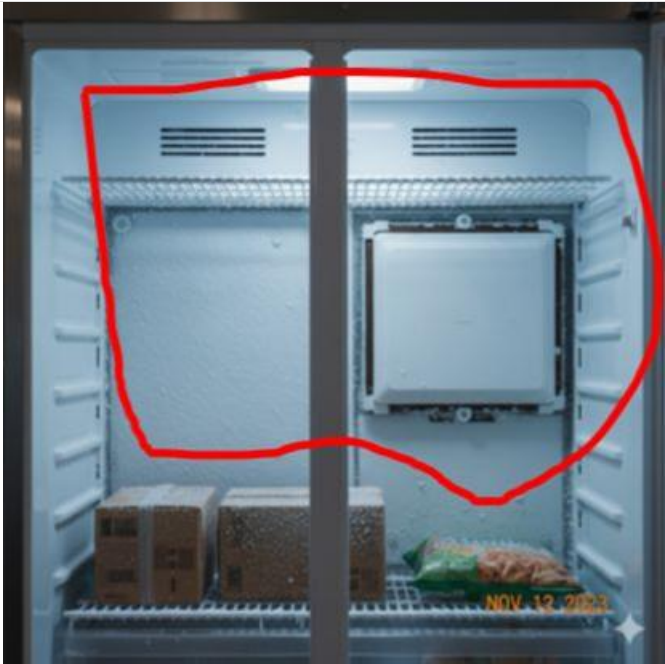
| Q# | QUESTION | RESPONSE |
|---|---|---|
| 34. | Unit operational<br>Unit is running and pulling down temperature successfully. Freezer reached -15 degrees and Fridge reached 4 degrees within the test period. | YES |
