## OSHA SCAFFOLD INSPECTION CHECKLIST

Millstone Avenue - Rutherford | Millstone Avenue,

FRIDAY 16TH OCTOBER 2026

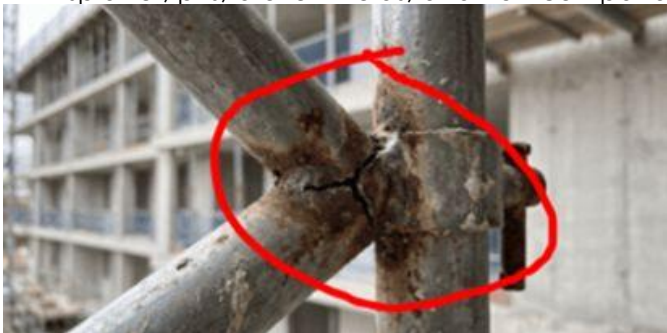
| Q# | QUESTION | RESPONSE |
|---|---|---|
| 6. | Are metal components free from bends, cracks, holes, rust, welding splatter, pits, broken welds, and non-compatible parts? | NO |

Surface corrosion on three frames at north elevation, bay 4. One cross-brace weld cracked at the collar. Frames removed from service pending replacement.

**FINDINGS** 'No' - Surface corrosion on three frames at north elevation, bay 4. One cross-brace weld cracked at the collar. Frames removed from service pending replacement.**ACTION REQUIRED** Replace corroded frames and cracked brace, north elevation bay 4**PRIORITY** High  
**DUE DATE** 17 Oct 26  
**ASSIGNEE** Jennifer Hunt

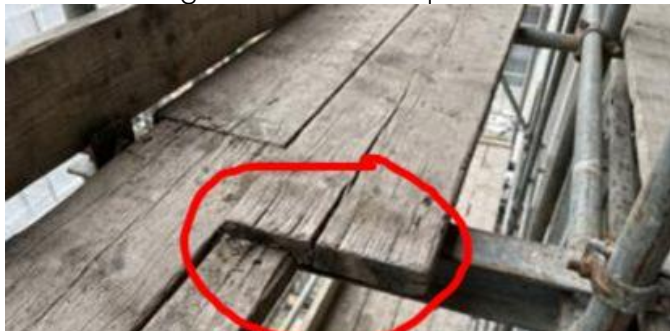
| 8. | Are wooden planks free from cracks, splits greater than 1/4 inch, long end splits, large loose knots, warps greater than 1/4 inch, gouges, mold, separated laminates, and excessive grain sloping (greater than 1 in 12 inches from the long edge), and are they scaffold grade lumber or equivalent? | NO |

Two platform planks at level 2 show through-splits over 1/4 inch at the bearing point. Planks not scaffold-grade stamped. Removed and barricaded.

**FINDINGS** 'No' - Two platform planks at level 2 show through-splits over 1/4 inch at the bearing point. Planks not scaffold-grade stamped. Removed and barricaded.**ACTION REQUIRED** Replace split platform planks, level 2**PRIORITY** Medium  
**DUE DATE** 23 Oct 26  
**ASSIGNEE** Jennifer Hunt
