# ACME COMPANY

## SUPPLIER NON-CONFORMANCE REPORT

### Supplier Non-conformance Report NCR Report

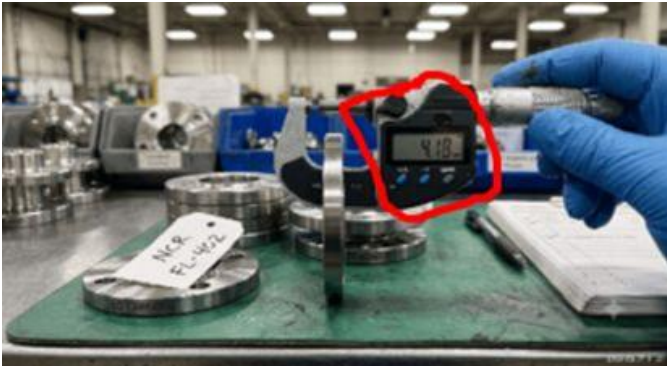
| Q# | QUESTION | RESPONSE |
|---|---|---|
| 1. | Please provide a description of the Non-Conformance | <p>During the incoming quality inspection of Lot #8849-B (Part Number: FL-402 Stainless Steel Flanges), a sample size of 20 units was pulled from a total shipment of 500 units. 18 of the 20 sampled units failed dimensional inspection.</p> |
| <p>07 Aug 26 02:08 PM</p> <p>The flange thickness measured between 4.10 mm and 4.25 mm. According to Engineering Drawing REV-C, the acceptable tolerance range is <math>4.50 \text{ mm} \pm 0.10 \text{ mm}</math>.</p> | | |

| Q# | QUESTION | RESPONSE |
|---|---|---|
| 2. | Enter the details of the investigation | <p>A CAPA request was issued to the supplier. The supplier's investigation revealed that a worn cutting tool was used on their CNC milling center, and the machine operator</p> |

| | failed to conduct the required hourly spot checks. To prevent recurrence, the supplier has replaced the worn tooling, implemented an automated tool-wear monitoring system on their CNC machines, and updated their SOPs to mandate supervisor sign-off on first-article inspections per shift. |
| 3. Any technical comments? | The undersized flange thickness directly compromises the structural integrity of the mating assembly in high-vibration operational environments. The risk of fatigue failure is too high; therefore, these parts cannot be reworked, shimmed, or approved for "Use As-Is." |
| 4. What is the Supplier Disposition Recommendation? | Reject and RTV. The entire lot of 500 units is to be returned to the supplier at their own expense for a full credit. A replacement shipment manufactured under the new quality controls must be expedited. |
